WORK SAMPLE

Santa Barbara Channel Hazards Removal Program
CSLC Bid Log No. 2008-09
General Notes

Santa Barbara Channel Hazards Removal Program
CSLC Bid Log No. 2008-09
Retaining Wall Hazard, Site No. 7

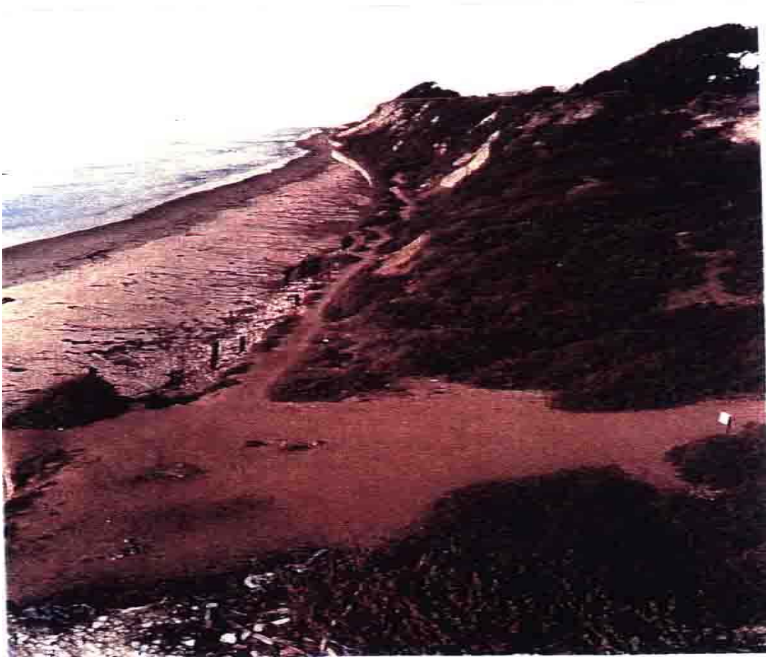
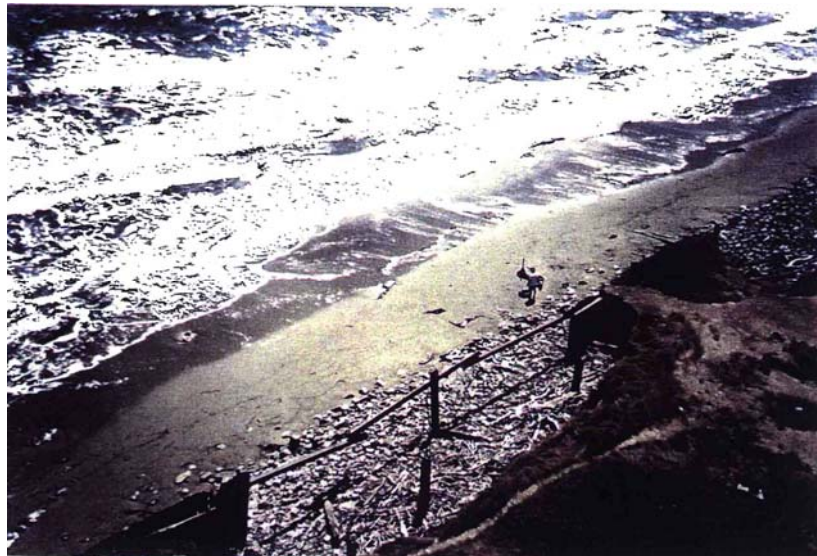
**Santa Barbara Channel Hazards Removal Program
CSLC Bid Log No. 2008-09
Retaining Wall Hazard, Site No. 7**

4,000 feet long wood sheet piles are sticking 6 ft to 8 ft above ground. The anchorage or foundation details of these sheet pile sections are not known. Certain portions of the sheet piling is acting as a retaining wall keeping soil from sliding.

Shows remnants of Wood Sheet Piles in 1993. This photograph was taken looking southwest immediately south of Santa Barbara Shores Drive.

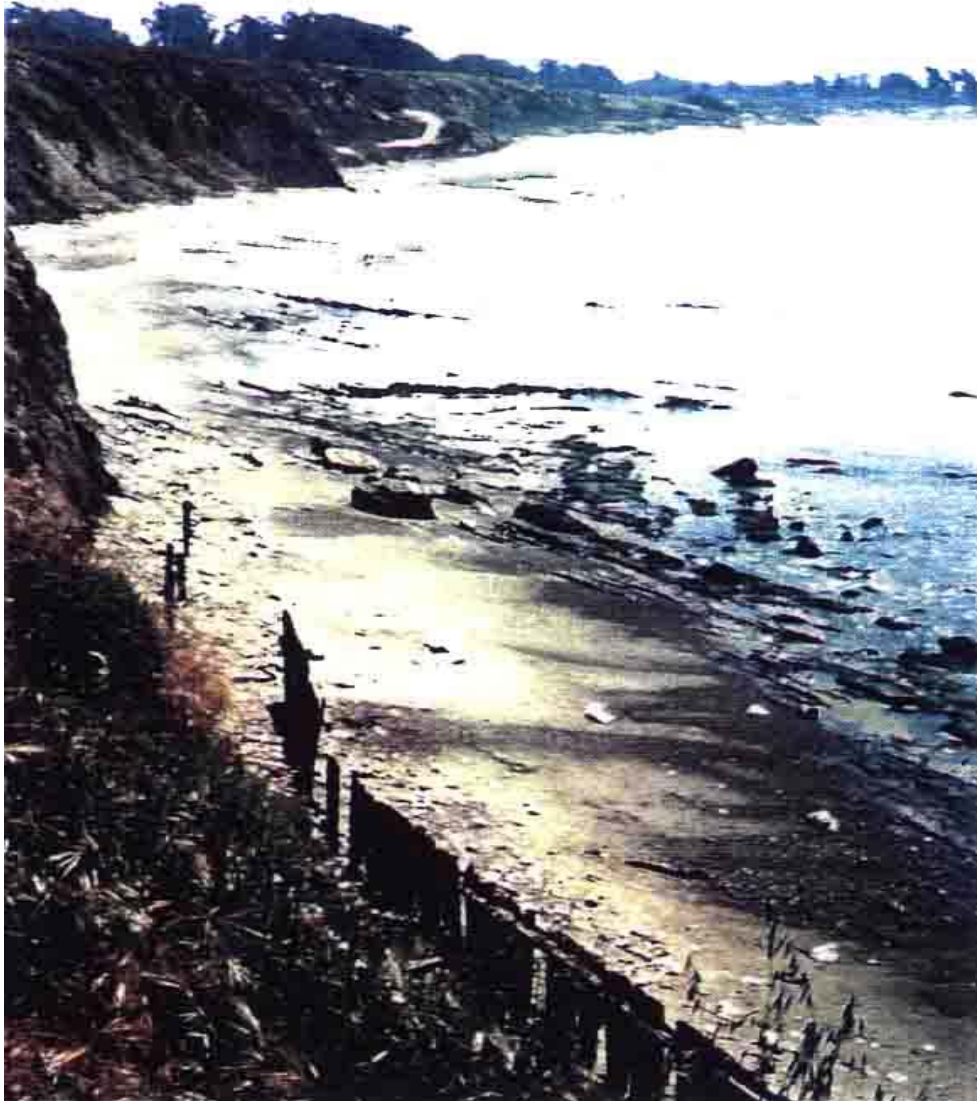
**Santa Barbara Channel Hazards Removal Program
CSLC Bid Log No. 2008-09
Retaining Wall Hazard, Site No. 7**

Shows remnants of Wood Sheet Piles in 1998. This photograph was taken looking southeast immediately south of Santa Barbara Shores Drive.

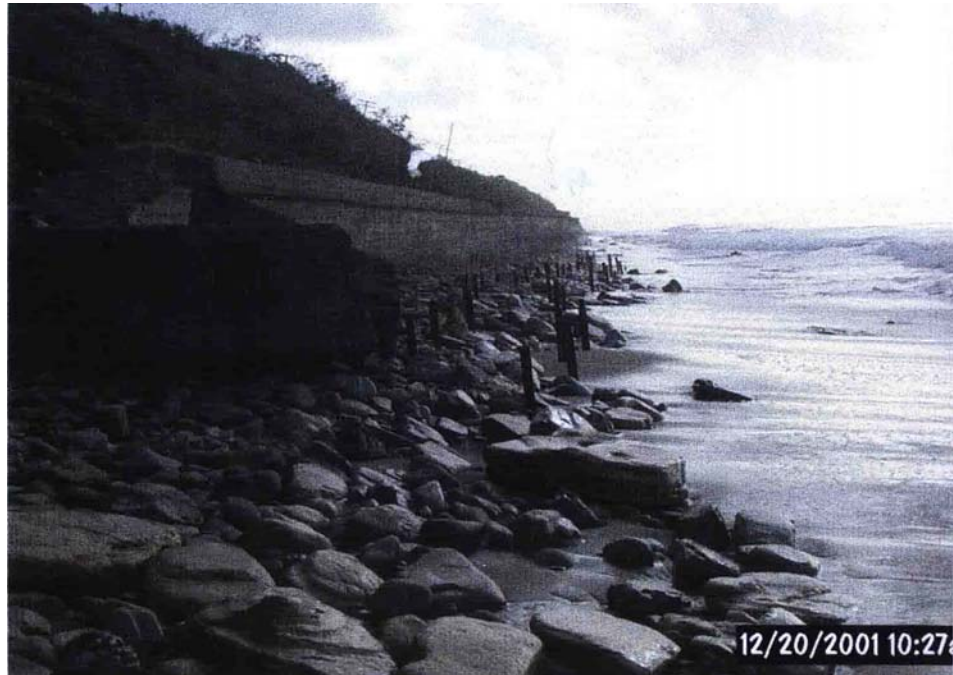
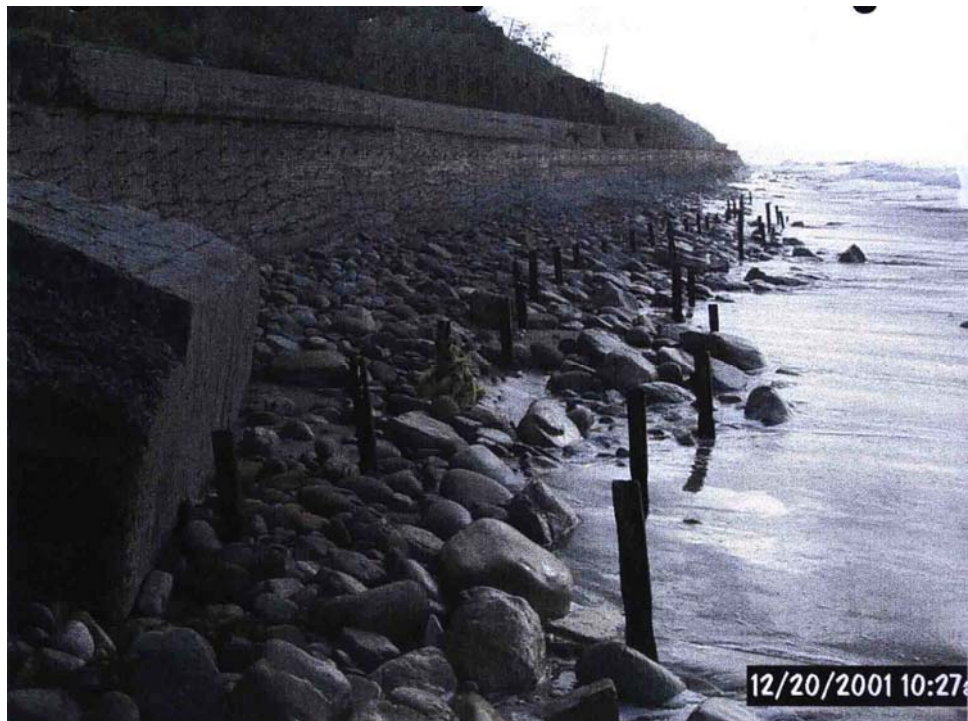
Santa Barbara Channel Hazards Removal Program
CSLC Bid Log No. 2008-09
H-Piles Hazard, Site No. 1

Seventy Railroad iron rods (H-Piles) spaced 10' to 15' apart are sticking out 1' to 5' above ground.

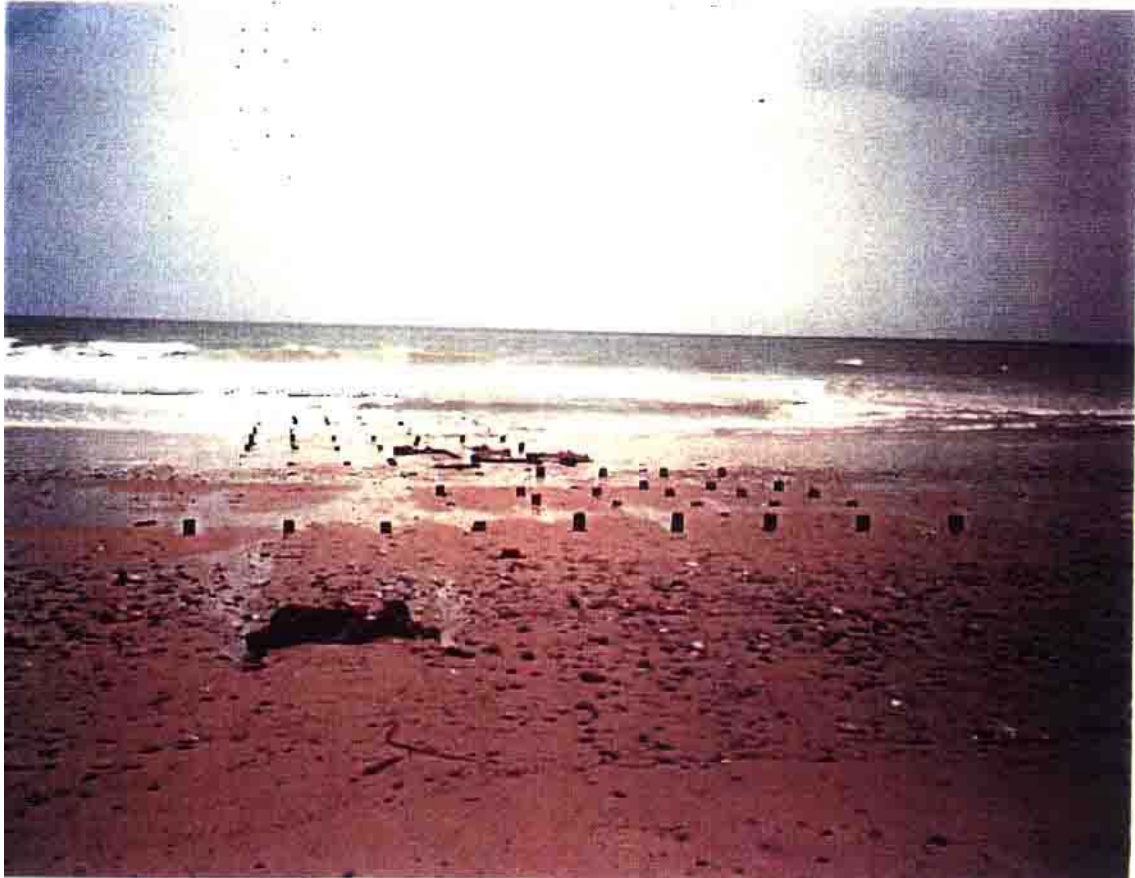
Santa Barbara Channel Hazards Removal Program
CSLC Bid Log No. 2008-09
Well Casings and H Piles, Hazard Site No. 6

Three 14" Well Casings are sticking out 1' to 4' above ground.

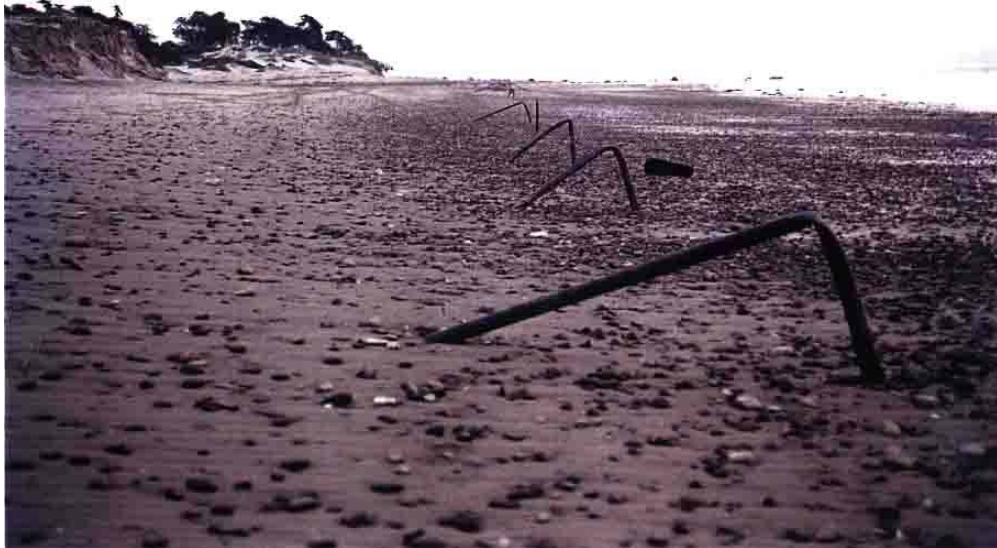
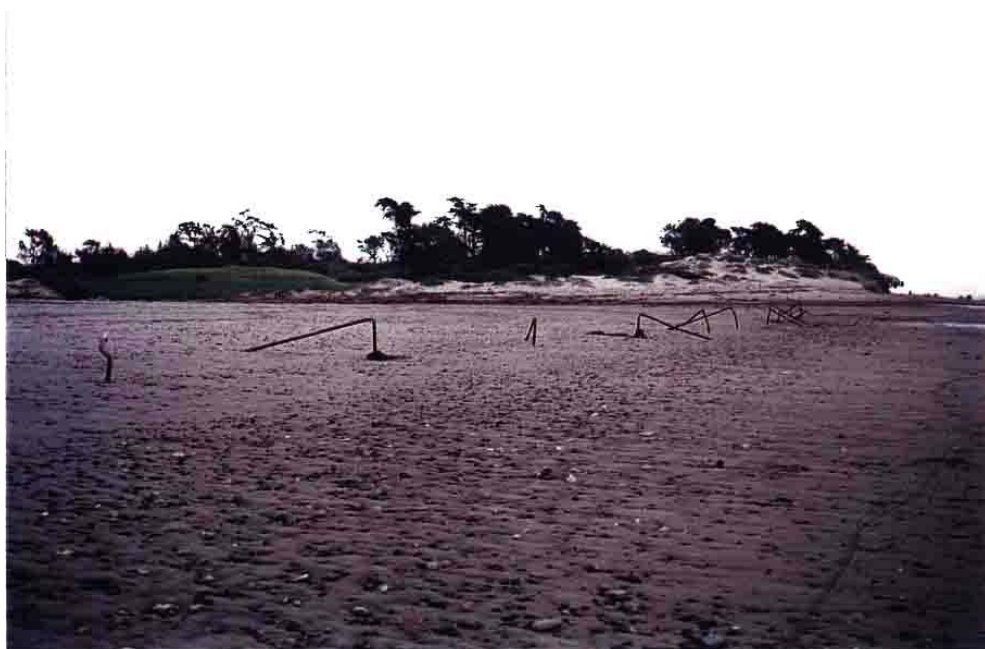
Santa Barbara Channel Hazards Removal Program
CSLC Bid Log No. 2008-09
Corroded Steel Frames, Hazard Site No. 8

Thirty 2 1/2" Corroded Pipe Frames are scattered along the shoreline.

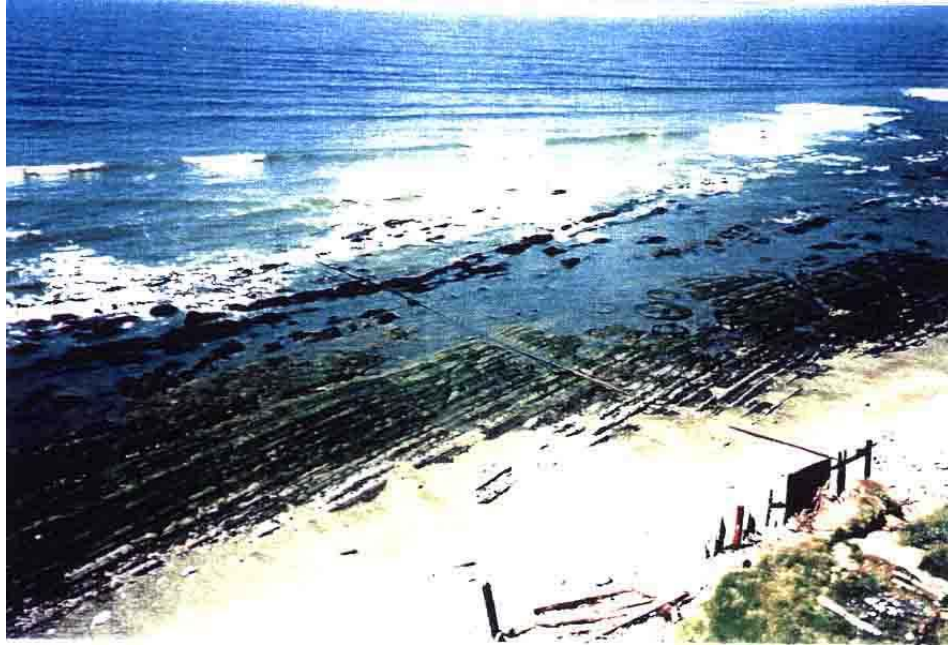
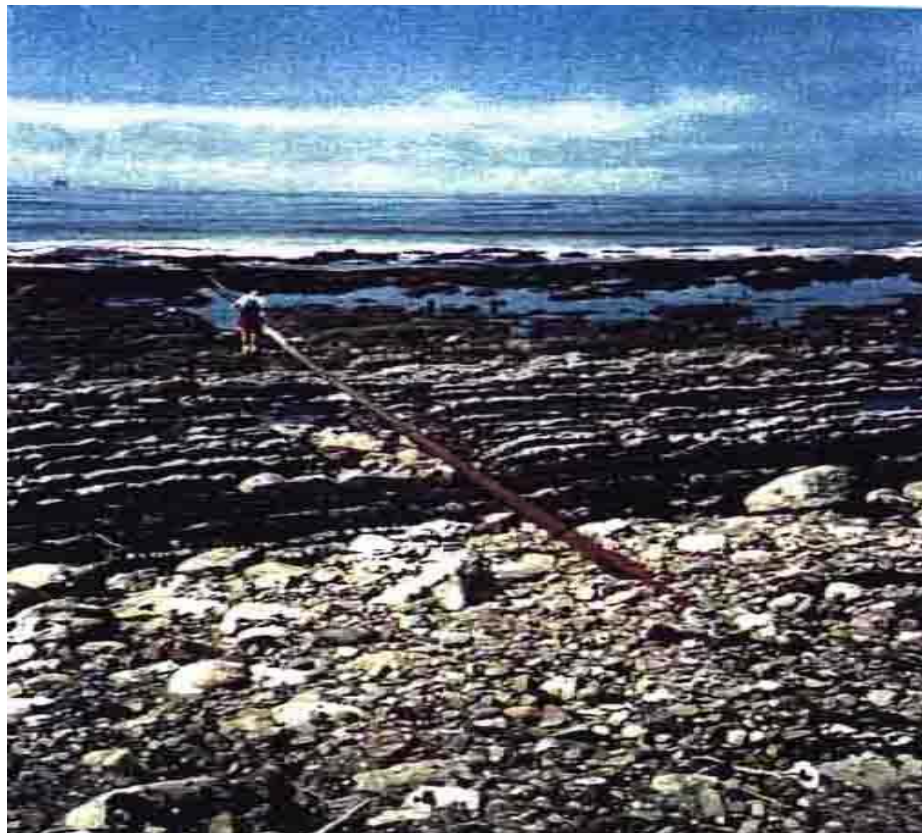
Santa Barbara Channel Hazards Removal Program
CSLC Bid Log No. 2008-09
Abandoned Pipeline, Site 6

500 feet of abandoned 6" Pipeline runs above ground from beach to the shoreline.

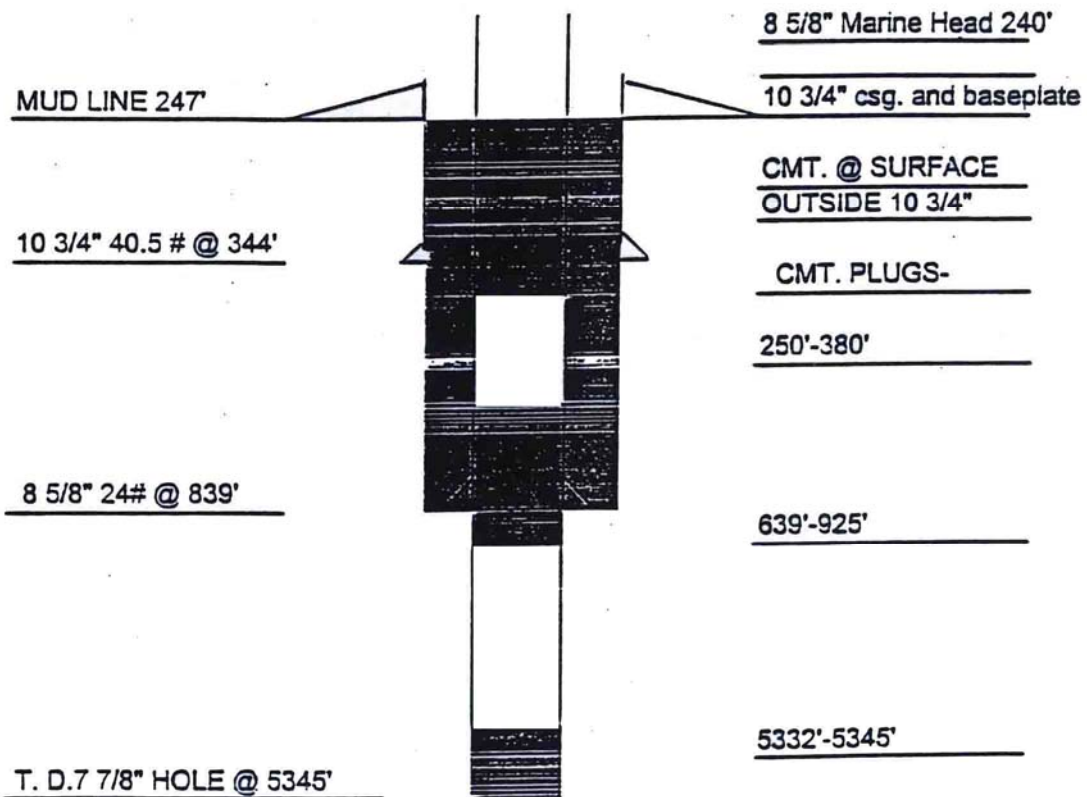
CURRENT CONDITION

This is an old abandoned well, Pauley Petroleum Inc. Core Hole 7B-19, PRC-2920. The task is for conducting the final abandonment and removal of the debris. The information provided here is based on the survey conducted over three years ago. Thus, the current condition and casing projections above sea floor may be significantly different from those shown in the attached figure.

Casing Record for the well: 10 3/4" casing set at 344', 8 5/8" casing set at 839' and 7 7/8" Hole to T.D. 5345'.

Plugged with cement from 5332' to 5345', 639' to 925', 250' to 380' (All depths measured from RKB which is 23' above Sea Level. Water depth is approximately 254').

To be determined by the contractor. Remove and recover the base plate and cut and recover 10 3/4" and 8 5/8" casings from a minimum of 1' below the mud line. Survey and recover any additional debris to complete abandonment. For the purpose of cost estimate, contractor shall assume ocean floor survey of 500' diameter prior to start of and at completion of the abandonment task.
